STRUCTURAL CONDITION ASSESSMENT & REHABILITATION OF EXISTING STEEL FACILITY USING NON DESTRUCTIVE TESTS & LATEST CODAL PROVISIONS

Milap D. Shah¹ | Jigar Rana² | AnilKumar Kannauzia³

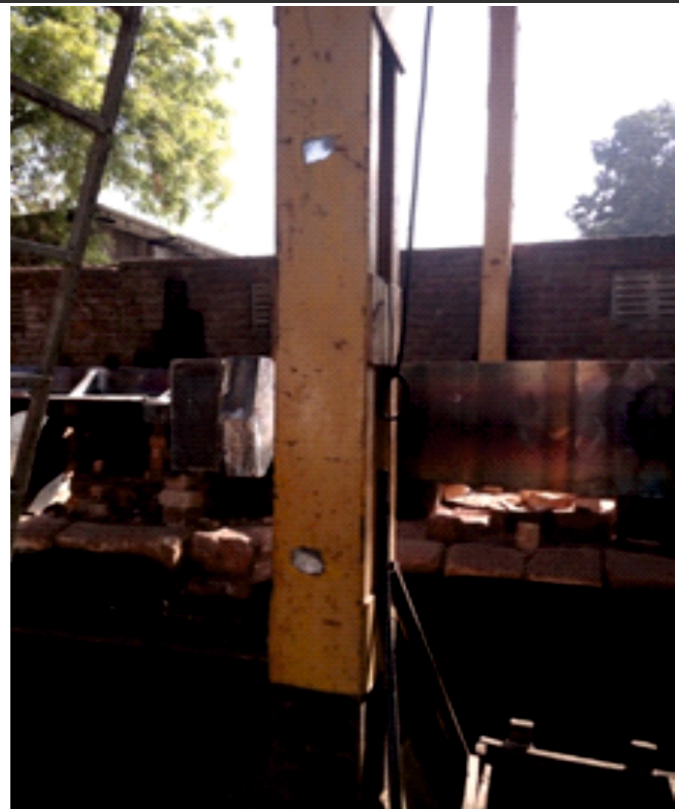
Fig.2 NDTs performed at 1.0 mt intervals

The detailed evaluation was carried out in this study for the detail evaluation of the existing structural members in the steel facility. Hence the Non-destructive Tests was performed on the structural members in the steel facility. The ultrasonic thickness measurement test, Hardness test, Coupons test was done in the facility. Before conducting Non-Destructive tests on the structural members the surface preparation was done on the structural members at testing points at 1.0 mt intervals.

i) **Ultrasonic thickness measurement :-** The ultrasonic thickness measurement test is carried out for the measuring the residual thickness in the existing structural members in the steel facility. In this research work UTG-III (Samsonic Make) used. The probe of the instruments is 10 mm Diameter, 5 MHz TR Normal Beam. The test method was conducting as per ASME sec-IV (Div 1). The thickness reading data were taken on the Beams such as ISMB 250, ISMB 400 & ISMC 100 in the steel facility at 1.0 mt intervals. Similarly the thickness measurements reading were taken at columns ISMC 200, ISMC 150, ISMC 75 at 1.0 mt intervals.

ii) **Portable hardness test:-** The portable hardness test is carried out for the taking the residual strength of the structural members in the existing steel facility. The portable hardness instrument MHT-100 (Samsonic make) was used in the research work. The testing methods was conducted as per A-370 standards. The hardness readings were taken same in the beams and columns where the Ultrasonic thickness measurement was done. As shown in fig.2 the NDTs were taken at 1.0 mt intervals on the structural members in the steel facility.

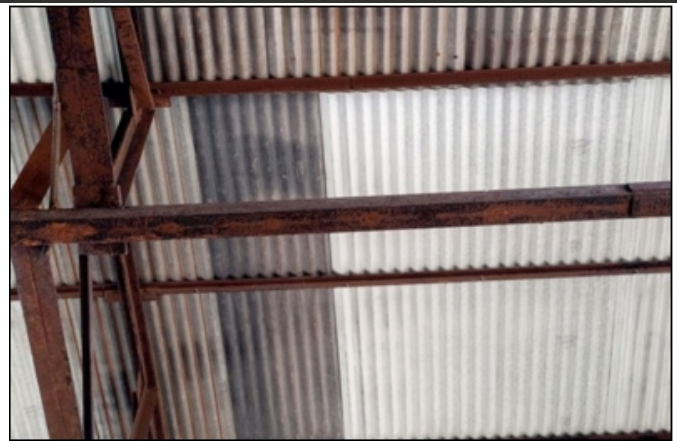
Fig.4 Corroded members in the facility

- a) The Members in the Existing Steel Facility is Heavily Corroded. Pitting is Taking Place on the Surface. Excessive Dent Mark on the Surface. As shown in fig.4

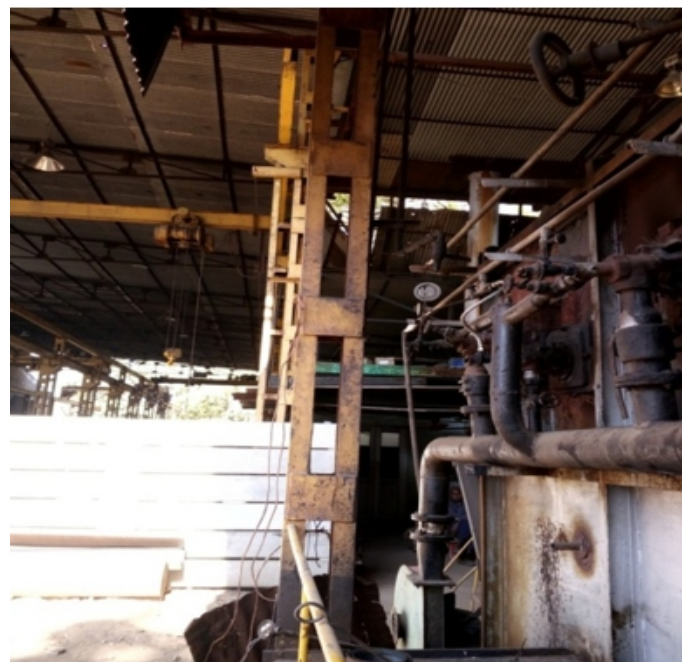
Fig:5 Deflection in the column

- b) The deflection is take place in existing structural members. As shown in fig.5

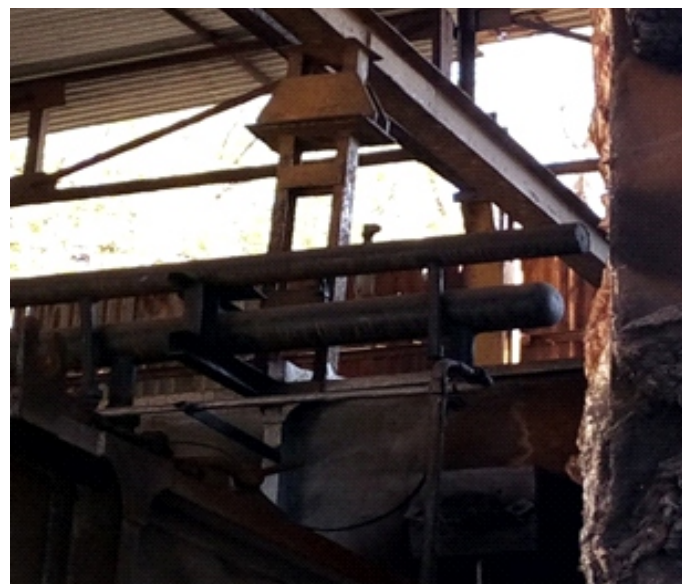
Fig:6 Corroded member in the steel facility due temperature changes

- c) The NDTs data seems to reduced in the residual strength of the many existing structural members in the facility and also reduced in the residual thickness of the beams near the furnace facility due to temperature variations. Hence many structural members are design deficient as per NDTs data & as per latest codal provisions.

- c) The Member Above the Furnace is Heavily Affected due to temperature changes n the Facility. Figure:4 shows the Member which is Affected due to Temperature Changes. The thickness of This Member is Lost due to Temperature. As shown in fig.6
